# BIJAO BEACH RESORT

GEO PRODUCTS, LLC | ENVIROGRID® GEOCELL

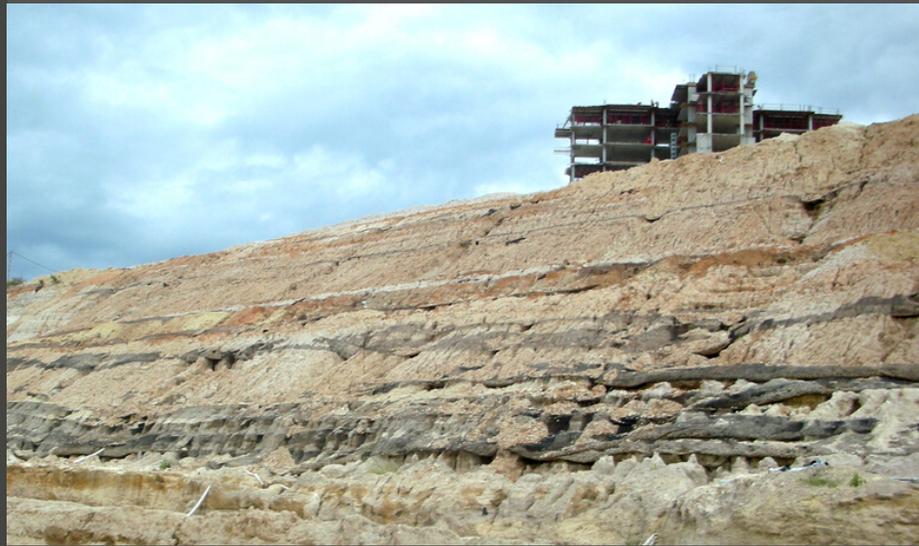
Bijao Beach Resort  
Pre-EnviroGrid® Slope Erosion Control System

The Bijao Beach Resort community resides in the balmy region of Panama near Santa Clara's beaches. It was constructed as a luxury resort to compete with nearby Playa Blanca and Decameron. An artificial mountain was created to enhance the geography of the resort. Native soil of the area was compacted and stabilized with biaxial geogrid, but rain has wreaked havoc upon the slopes. Severe erosion has caused extremely large ruts to form in the sides of the mountain, threatening its integrity.

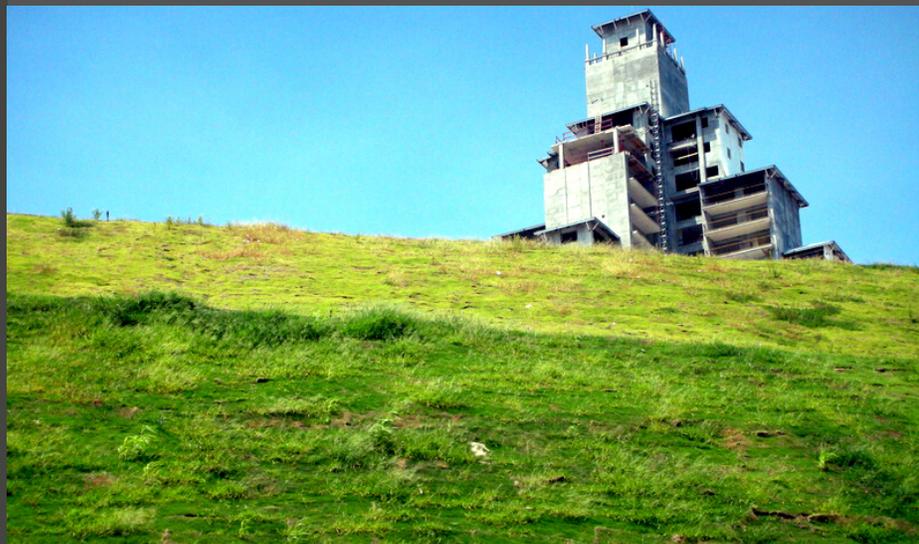
Bijao Beach Resort  
With EnviroGrid®

A 4" perforated EnviroGrid® GeoCell was placed directly on the slopes. The panels were anchored in place with polyester tendons along the entire slope, including the 5 meter shelf area. The tendons were dead-man anchored at the top of the slope and adjacent panels stapled. The EnviroGrid® was filled with local sandy soil and hydro-seeded with Saint Augustine grass seed. The 4,500 m<sup>2</sup> of EnviroGrid® were installed in 2 weeks by a crew of 8 men.

After construction contractors continued to irrigate the slope, preventing additional erosion within the cells while the vegetation was taking root. At 4 weeks, abundant vegetation growth was observed and responsible gardeners kept the slope hydrated.
